Mauro Pompetti, CEng, DronesBench, Foggia, Italy

Case study #1: Drone Tali H500

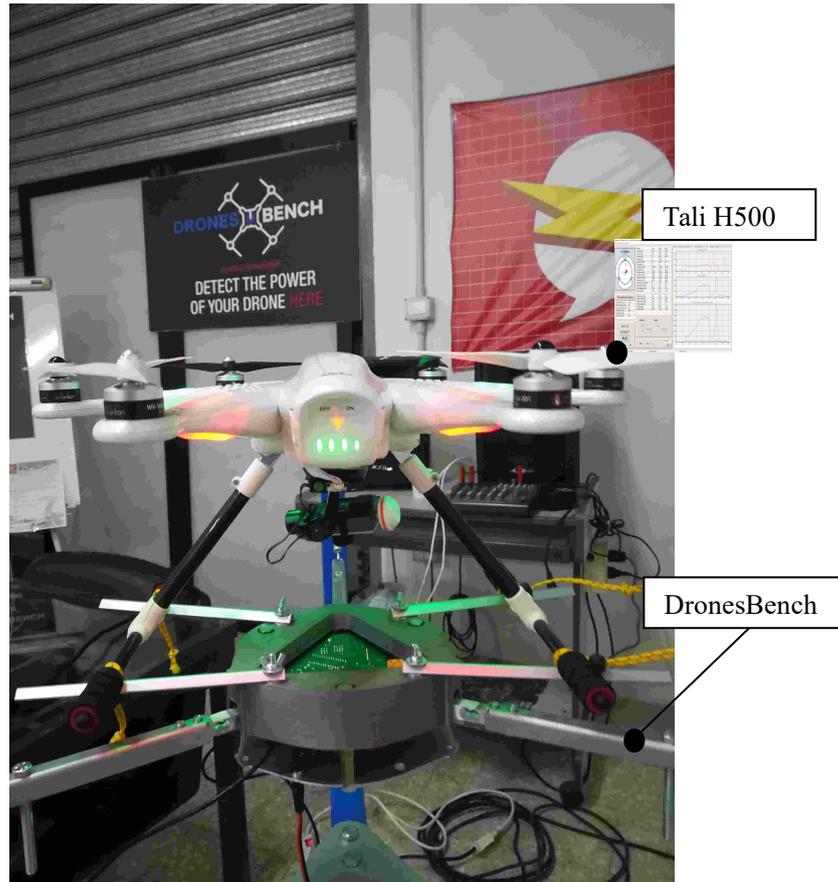
Figure 1: Fixing the drone to the DronesBench before the test

Below is a photo of the drone before the test.

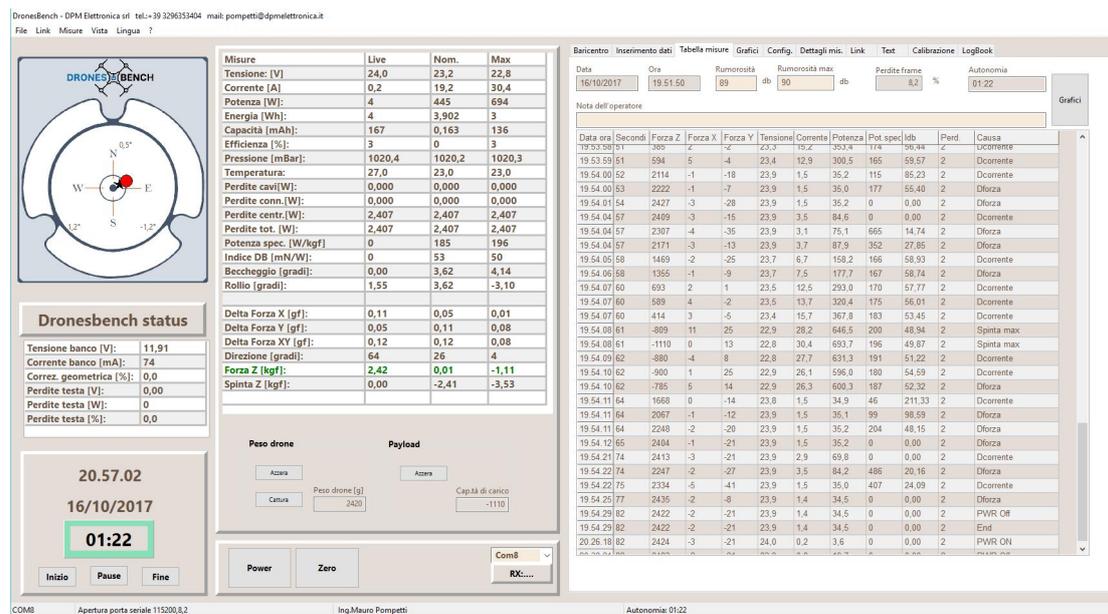
Figure 2: HMI Interface with Measuring Tables

Figure 2 and Figure 3 below show the HMI interface developed to analyze the data from the measuring instrument.
